Thirteenth Bjerrum Memorial Lecture: A case history of mysterious settlements in a building

J. M. DUNCAN

This lecture describes the investigation of large and damaging settlements in the One Lombard Building in San Francisco Calif. The cause of the settlements was a mystery. Although it was known that settlement began during construction of a major new sewer near the building, it was not clear how the settlements could be related to the sewer construction activities. The paper explains the cause of the settlements and describes the technique used to remedy the problem. The legal and insurance aspects of the case, in some ways more mysterious than the technical aspects, are also described.

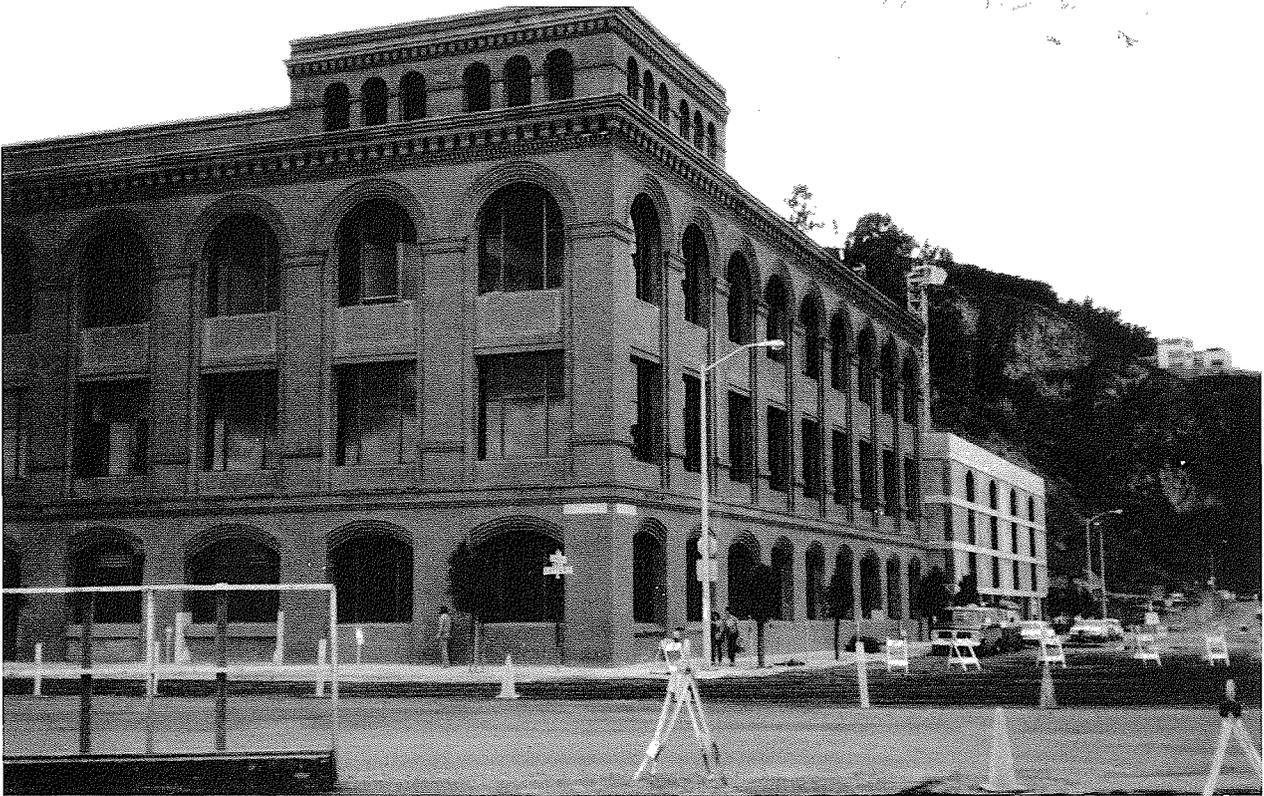
The One Lombard Building is located, as shown in Fig. 1, at the northeast corner of Lombard and Battery streets, east of Telegraph Hill, in San Francisco. Built in 1901, it was owned by the Union Can Company and was originally called the Merchants Ice and Cold Storage building (Olmsted *et al.* 1977). As can be seen in Fig. 2, the building is three stories high and is constructed of brick.

FIG. 2. Photograph of the One Lombard Building, with sewer excavation at bottom and Telegraph Hill visible in background.

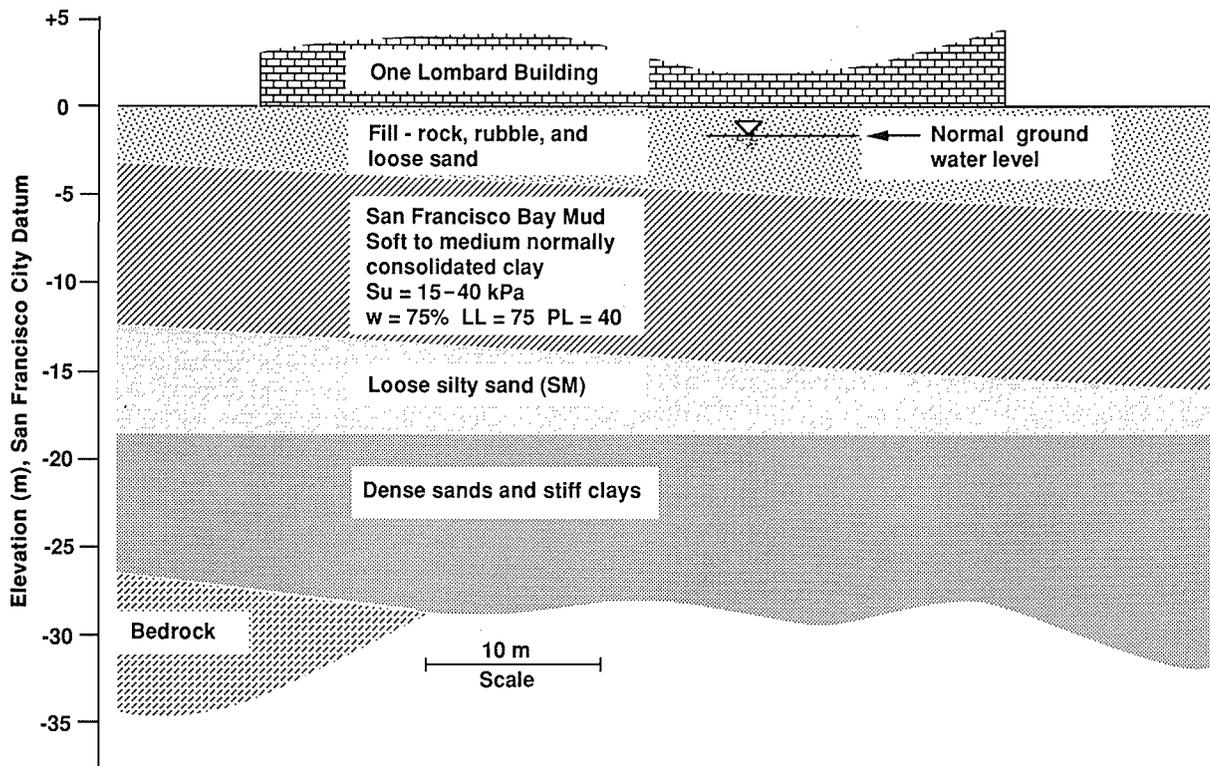
The soil conditions beneath the building are shown in Fig. 3. In approximately 1881, 3-5 m of rock, rubble, and loose sand were filled on top of the Bay Mud at the site to raise the area above the level of San Francisco Bay (Dow 1973). The Bay Mud beneath the building is about 10 m thick; it is underlain by 3-5 m of loose silty sands and, at greater depths, by dense sands and stiff clays overlying the Franciscan bedrock (Harding-Lawson Associates 1976). The exterior walls and the upper two floors of the building are supported on wooden piles that are believed to extend down into the loose silty sand. The ground floor is a concrete slab, supported directly on the ground.

FIG. 3. Soil conditions at One Lombard. Section along Battery Street, looking west (after Harding-Lawson Associates 1976).

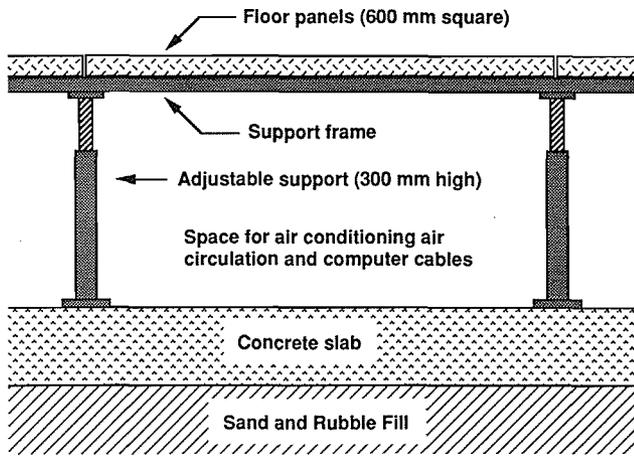
As shown in Fig. 4, this computer floor consists of 600 mm square panels supported on a steel frame. The steel frame is in turn supported by adjustable supports 300 mm high, resting on the concrete slab on grade.

FIG. 4. Floor system used in computer rooms.

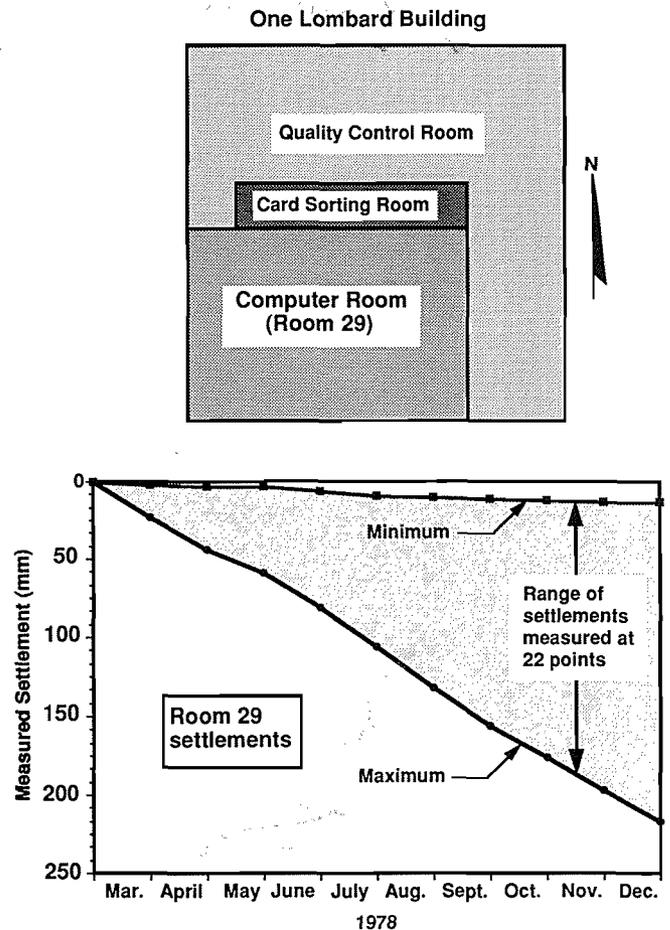
Early in 1978, soon after the building was renovated and occupied, the ground floor tenant began to experience problems with the operation of the computers and tape drives in the first floor of the building. It was discovered that these problems were due to movements of the computer floor, which were caused by settlements of the slab that supported the computer floor system. Settlement measurements were begun in March 1978. The settlements measured in room 29 are shown in Fig. 5. It can be seen that, by the end of August 1978, the measured settlements varied from a minimum of a few millimetres to a maximum of about 125 mm.

FIG. 5. Measured settlements in the One Lombard Building.

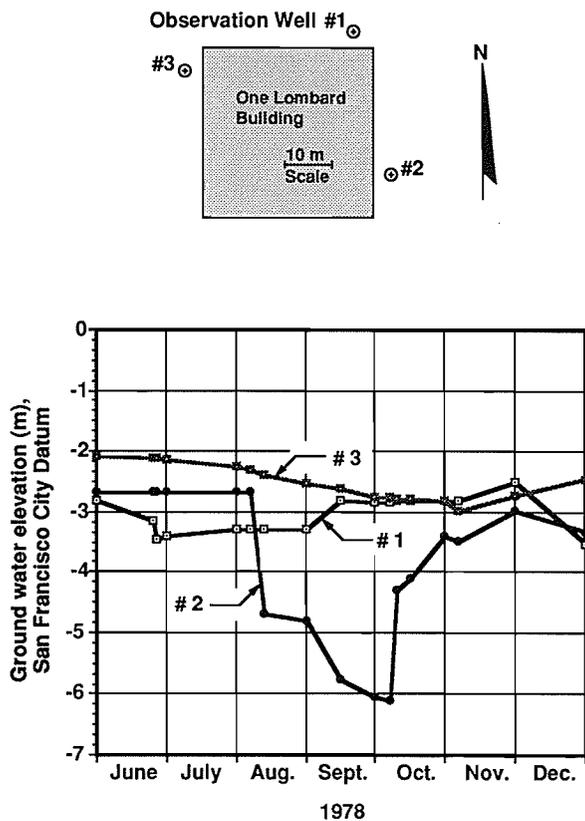
The building owners had installed three observation wells around the building in June 1978. As shown in Fig. 6, the measured water levels were lower than normal, which in this area was about -2 m San Francisco City datum. At well 2 the water level was about 3 m lower than normal in August 1978. It was suspected that these abnormally low water levels were caused by dewatering for a sewerage pumping plant being constructed along the sewer line about 300 m north of the building. At the pumping plant the water level had been lowered about 20 m by the dewatering. In the opinions of the building owners, this dewatering was the most likely cause of the large and damaging settlements in their building.

Observations of the groundwater levels around the building continued in September through December 1978, as shown in Fig. 6. The water level in observation well 2 continued to drop until early October and then rose rapidly to a level about 1.0 m below normal. During this period, however, the settlements continued at an undiminished rate. By December 1, 1978, the maximum measured settlement in room 29 had increased to 200 mm. The rate of settlement was as large as ever, despite the fact that the groundwater levels near the building had returned to near-normal levels.

FIG. 6. Water levels in observation wells.

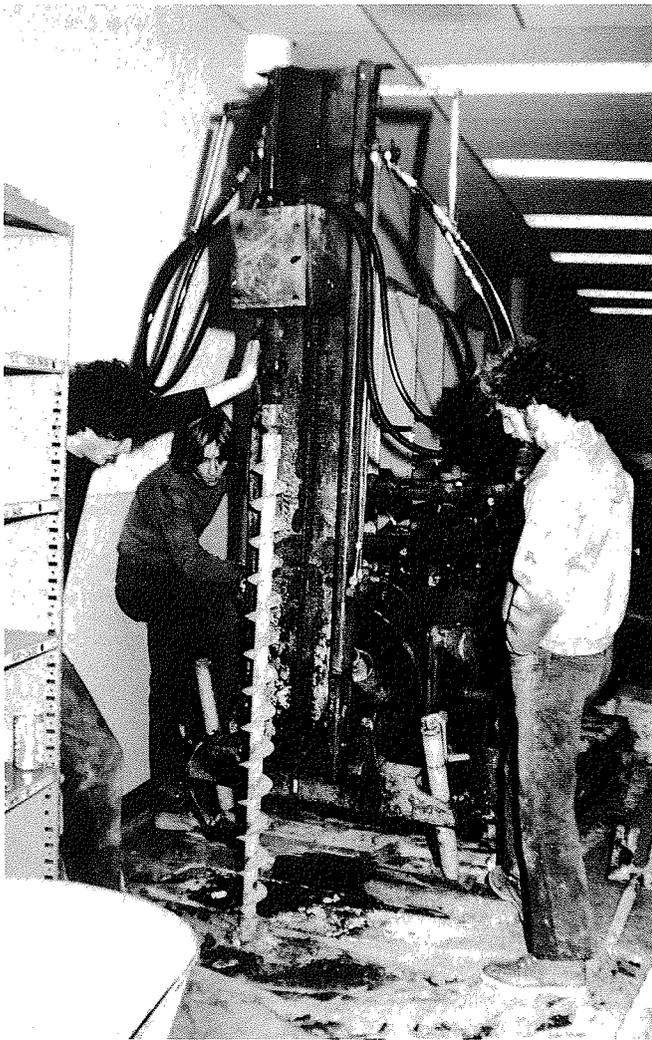
After coring through the concrete floor, drilling was begun with an auger, as shown in Fig. 8. After advancing a short distance, the auger encountered an obstruction, probably a piece of rubble or a large rock. More than an hour of drilling produced only 1-2 mm advance. However, it was decided to continue because it seemed certain that once the

FIG. 8. Drilling beneath the floor slab at borehole A inside the One Lombard Building, adjacent to room 29.

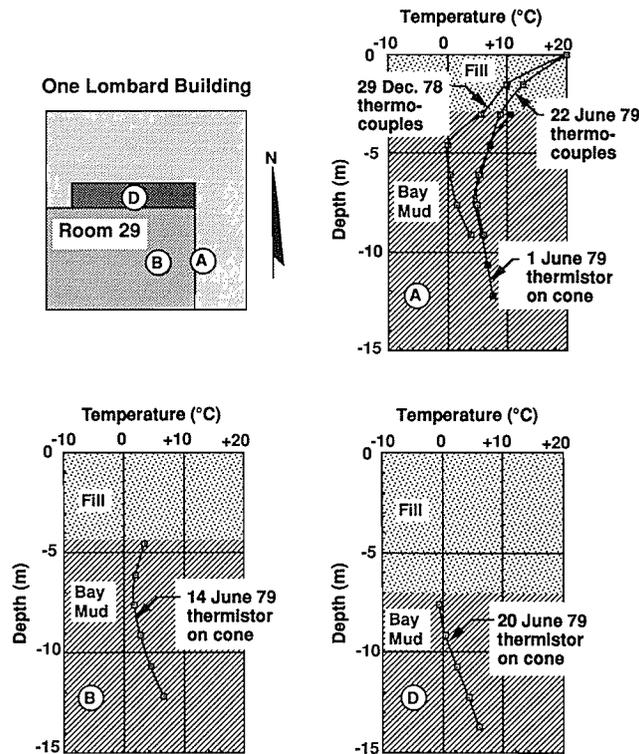
The thermocouple string was installed at this location (hole A) on December 22, 1978. The ground temperatures 1 week later are shown in the upper right corner of Fig. 10. It can be seen that the minimum temperature, at a depth of about 4.5 m, is 0°C . The salinity of the water in the Bay Mud was about 17 000 ppm, and the freezing temperature was estimated to be about -2.2°C . Although the mud was not frozen at 0°C , it had been warming for 18 months, and it was clear that it had been frozen during the frozen food storage operation.

FIG. 10. Measured temperatures beneath the One Lombard Building.

The soil conditions at the locations of the borings, and the measured ground temperatures, are shown in Fig. 10. The ground temperatures at the new boring locations (B and D) were measured using a thermistor on the tip of a cone penetrometer. This technique was used also at a new hole adjacent to hole A, where the thermocouple string had been installed. As shown in the upper right part of Fig. 10, ground temperatures measured on June 22, 1979, using the thermocouple string were essentially the same as those measured on June 1, 1979, using the thermistor on the cone. This similarity indicates that the measurements made with the thermistor are accurate. The coldest ground temperature measured anywhere beneath the building was -1°C , measured in hole D on June 20, 1979.

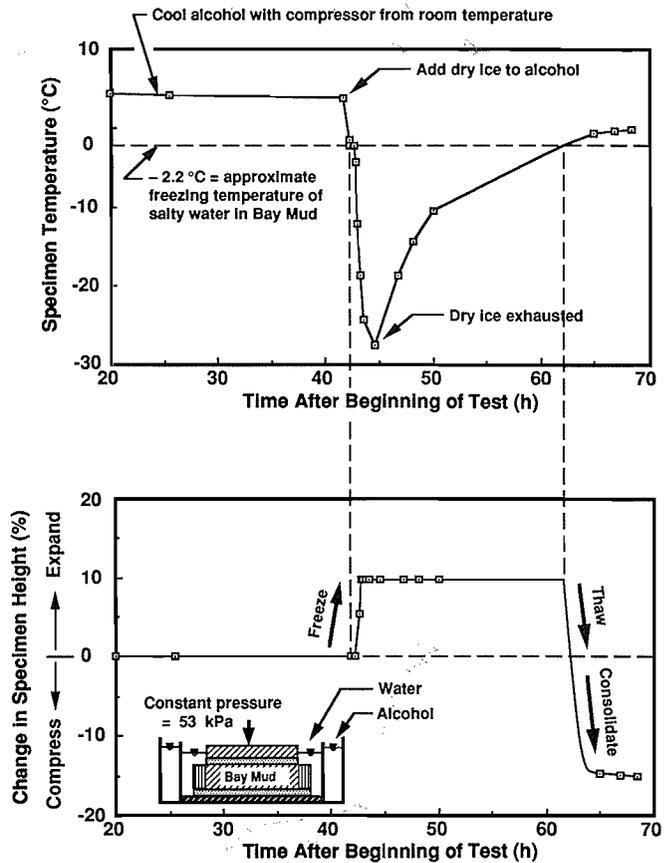
As shown in the lower part of Fig. 11, the height of the specimen remained constant until the specimen froze. Then the height of the specimen increased by about 10%. During the period while the specimen was frozen, its height remained constant. When it thawed, its height decreased, first due to thawing, and then due to consolidation. Eventually, when it again came to equilibrium under the 53 kPa load it had carried all the time, its height had decreased by 15%.

These results show that freezing and thawing Bay Mud could result in settlements, in this case 15% of the frozen thickness. As the water in the voids of the Bay Mud freezes and expands, adjacent particles are moved apart, and whatever bonds exist between them are broken. The result is that when the mud thaws, it is essentially a completely remolded material, no longer in equilibrium with the load it carried previously. Consequently, it consolidates until it reaches a new equilibrium condition under the load, and as it consolidates it compresses.

FIG. 11. Freeze-thaw test on undisturbed San Francisco Bay Mud.

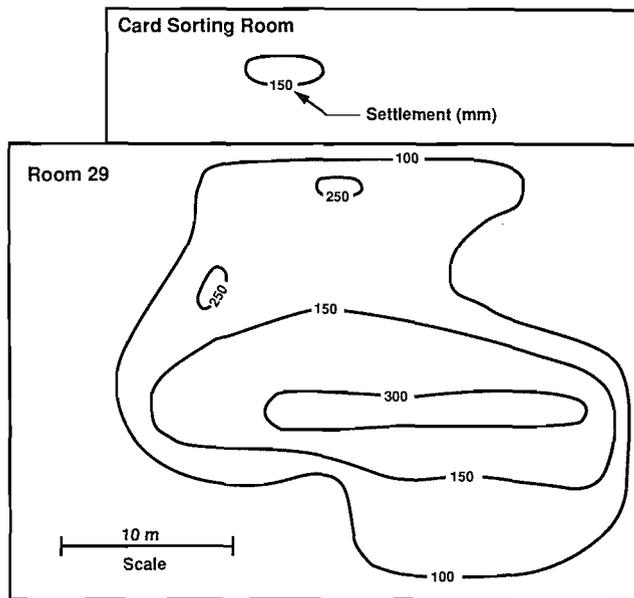
FIG. 12. Settlement contours based on measurements of distance from computer floor down to top of concrete slab, April 1979.

The magnitude and extent of the settlements in room 29 and a card-sorting room were surveyed by measuring the distance from the bottom of the frame supporting the computer floor to the top of the concrete slab. Assuming that the maintenance operation had kept the computer floor at the same elevation while the slab settled (a reasonable presumption), the settlement at any point could be estimated as the difference between the measured spacing and the initial spacing (300 mm). This method was an improvement over the settlement measurements that had been made previously because all parts of the rooms could be included, and because some settlement had occurred before the settlement measurements were begun. Contours of settlement determined in this way are shown in Fig. 12. The largest settlements, near the center of room 29, were slightly more than 300 mm.

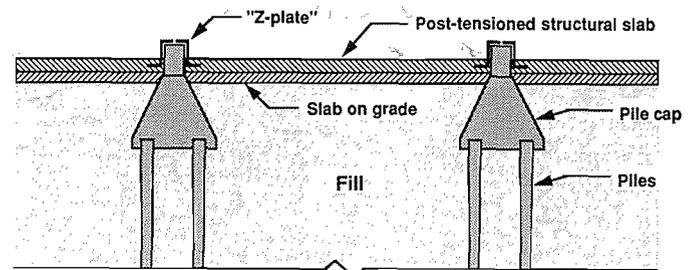
FIG. 13. Post-tensioned structural slab and "Z-plate" connection to pile cap.

By analyzing the loads on the existing piles and estimating their capacities, it was concluded that a new structural floor could be supported by the existing piles without causing them to settle significantly. On this basis option 2 above was chosen, and a structural slab was built in room 29 and the card-storing room. One of the owners of the building was an innovative contractor who managed to construct the new slab without moving the ground floor tenant out of the building. This was done by building the slab bit by bit, in 5 m square sections. The post-tensioned slabs were supported from the existing pile caps as shown in Fig. 13. A photograph of one of the "Z-plate" connectors between the slabs and the pile caps is shown in Fig. 14.

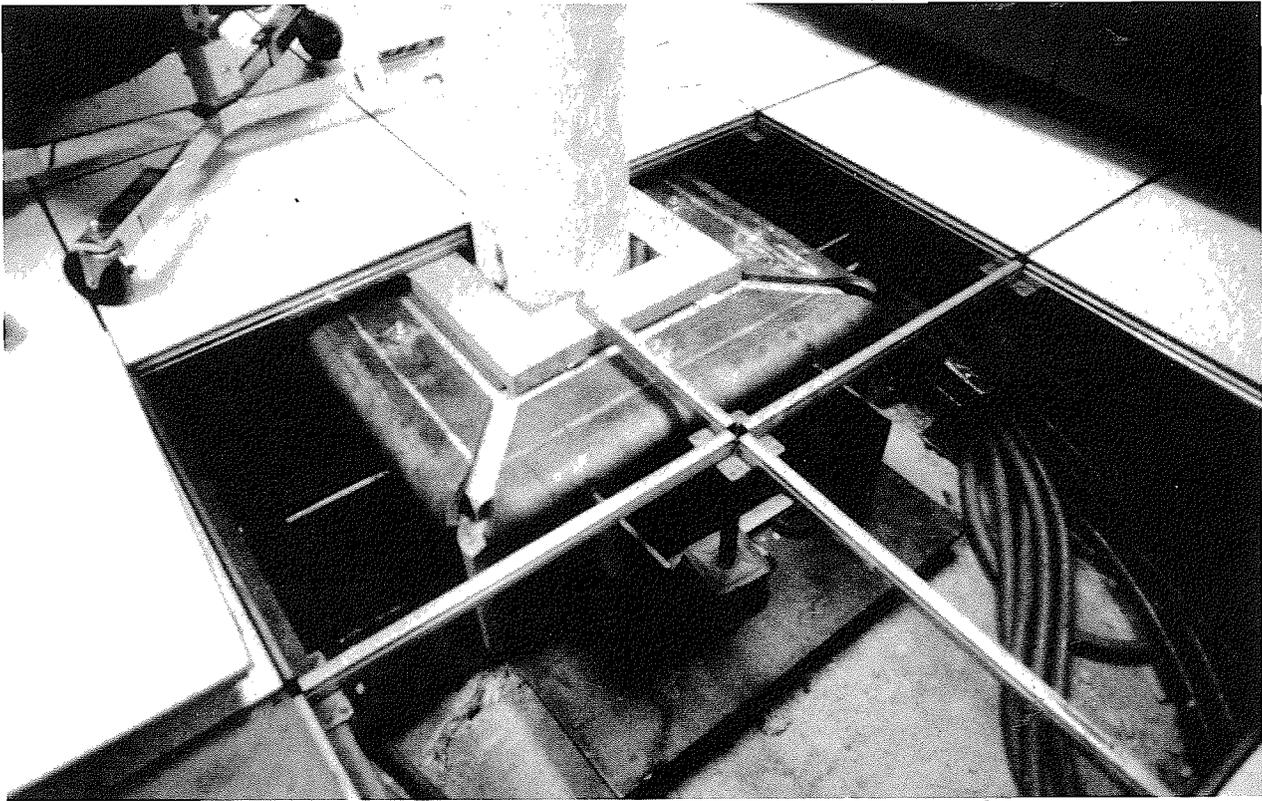
FIG. 14. "Z-plate" used to transfer load of new post-tensioned slab (not yet poured when photograph was taken) to top of existing pile cap.
