Thirteenth Bjerrum Memorial Lecture: A case history of mysterious settlements in a building

J. M. DUNCAN

This lecture describes the investigation of large and damaging settlements in the One Lombard Building in San Francisco Calif. The cause of the settlements was a mystery. Although it was known that settlement began during construction of a major new sewer near the building, it was not clear how the settlements could be related to the sewer construction activities. The paper explains the cause of the settlements and describes the technique used to remedy the problem. The legal and insurance aspects of the case, in some ways more mysterious than the technical aspects, are also described.

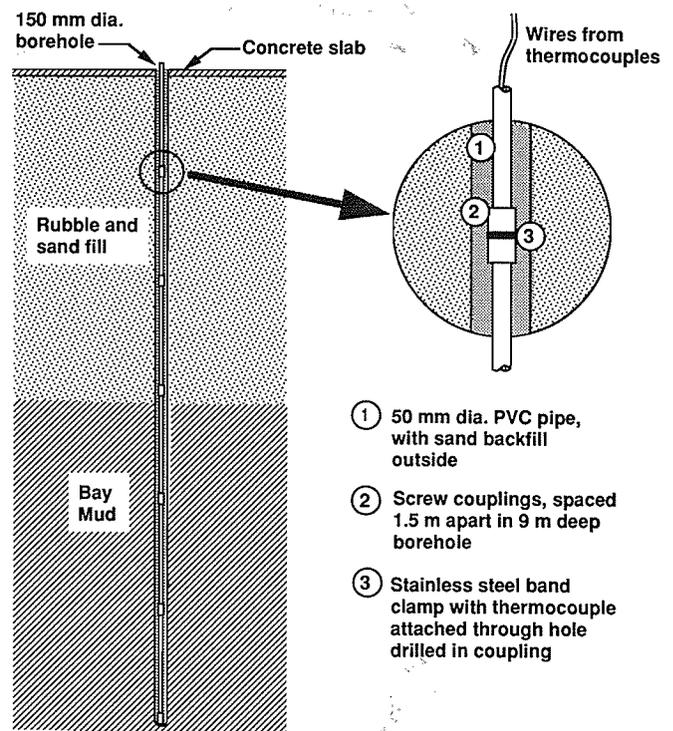
FIG. 7. Thermocouples in PVC casing used for measuring ground temperatures (designed and built by C. Chan, University of California, Berkeley).

To make these measurements, the device shown in Fig. 7 was developed by Clarence Chan, another of the writer's colleagues. It consists of PVC pipe, in 1.5 m lengths, with screw couplings. A stainless steel band clamp was attached around each coupling, with a thermocouple attached through a hole drilled through the plastic coupling. The thermocouple wires extended to the surface inside the watertight PVC casing. The instrument was light and easily portable. The entire device could be folded into a 1.5 m length and carried in one hand. It was assembled one section at a time as it was lowered into a 9 m deep borehole and was backfilled with uniformly graded sand after the full length had been installed. Two trial runs were made, installing these devices at locations outside the building, to be sure all the problems had been solved before attempting to install one inside the building. Both of the trial devices worked well, reaching stable temperatures within an hour after installation.

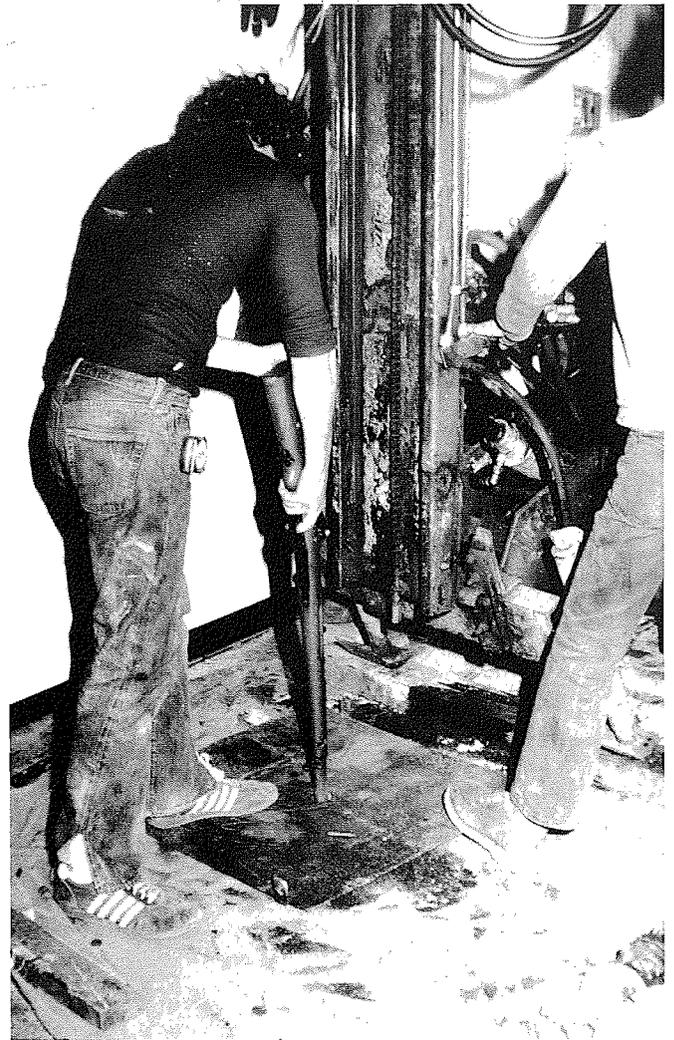
messy drill rig was removed, it would never be permitted in the building again. At this point the drill foreman (an 18 year old driller with 20 years of experience) suggested a way to solve the problem. He said that in previous cases where he had run into problems with obstructions, he had fired a few rounds from his 30.06 rifle down the hole to break up the obstruction. The writer agreed that this sounded like a good idea, especially since there did not seem to be any alternatives. Within an hour and a half the driller retrieved his rifle and brought it into the building, wrapped in a blanket to keep it out of sight of the office workers, who already viewed our operation with revulsion. Then, as shown in Fig. 9, the driller fired five rounds down the hole. His previous experience with the technique seemed to be confirmed by the fact that he brought not only the rifle, but a steel plate with a hole in the center to catch any bullets that might ricochet off the obstruction.

After this treatment, the drill rig was moved back onto the hole and broke through the obstruction. When the Bay Mud was encountered beneath the fill, and handfulls were removed from the auger flight, it was very easy to discern that the mud was extremely cold. Holding the mud in one's hand was like holding a handful of ice cream. Even before

FIG. 9. Firing the 30.06 rifle down the borehole to break up an obstruction.

the thermocouple string was installed and ground temperatures were measured, it was clear that the Bay Mud must have been frozen, because even 18 months after shutdown of the freezer system, its temperature was still close to freezing.
